**Jaroslav SOJKA¹, Michel JEROME², Céline LY², Ivo SCHINDLER¹, Petra VÁŇOVÁ¹,
Andrea WENGLORZOVÁ¹, Maria SOZANSKA³**

HYDROGEN EMBRITTLEMENT OF DUAL PHASE AND TRIP STEELS

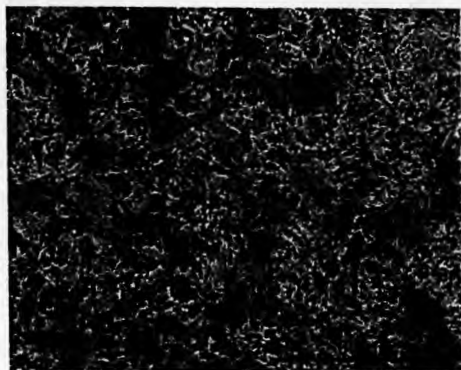
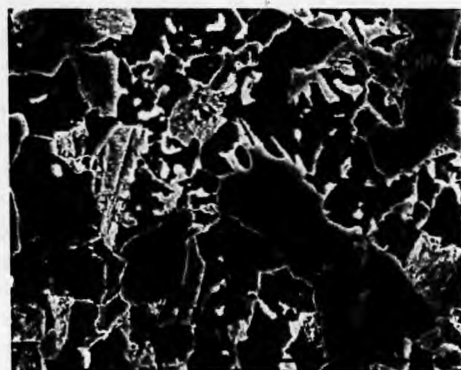
Fig. 1 Microstructure of the DP 750 steel (Nital etching, SEM)

Steel microstructures were studied using light microscopy (LM) and scanning electron microscopy (SEM). They are shown in Fig. 1 and 2. The microstructure of DP 750 steel consists of ferrite and martensite (Fig. 1). The quantitative structure analysis, to determine the amount of ferrite and martensite, has not been performed. TRIP 800 steel has the microstructure consisting of ferrite, bainite and martensite. Fine carbide particles can be observed in the microstructure of the TRIP 800 steel. Two different micrographs are presented for the TRIP steel. The first one is after conventional Nital etching (Fig. 2a), the second one (Fig. 2b) is after special coloured etching by Le Pera [9]. For Le Pera etching, it is assumed that ferrite is blue coloured, bainite is brown and regions containing a high amount of austenite are white.

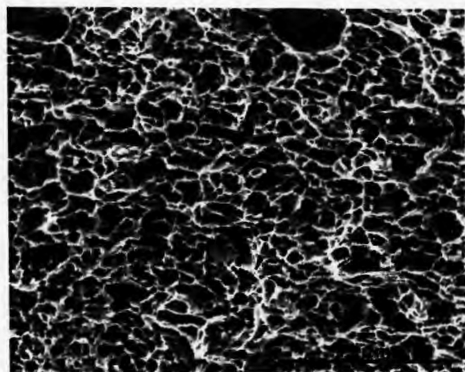
a) dp steel after hydrogen charging at $15\text{mA}\cdot\text{cm}^{-2}$ for 4 hours

Fig. 3 Fracture surfaces of the dp and trip steels after hydrogen charging without As_2O_3 addition

Fractographic analysis revealed that hydrogen charging without As_2O_3 addition resulted only partially in the change of the failure micro mechanism for the DP 750 steel. In this steel, the failure was still predominantly transgranular ductile with dimple morphology, even after hydrogen charging. Nevertheless, the dimples were shallower in the presence of hydrogen. Profile analysis performed for DP 750 steel showed that in the as-received state the average dimple depth was $3.8 \pm 0.3 \mu\text{m}$. After hydrogen charging at the current density of 15mA·cm⁻² for 4 hours, the average dimple depth was only $2.4 \pm 0.2 \mu\text{m}$ (Fig. 3a).

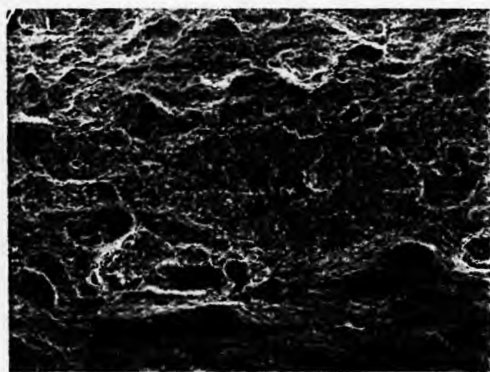
b) trip steel after hydrogen charging at $15\text{mA}\cdot\text{cm}^{-2}$ for 4 hours

In the TRIP 800 steel, special defects provoked by hydrogen were observed on the fracture surfaces – so called “fish eyes”. Fish eyes represent less or more circular areas of quasi-cleavage fracture around non-metallic inclusions, which act as the crack initiation sites. An example of a fish eye found in the TRIP 800 steel is given in Fig. 3b.

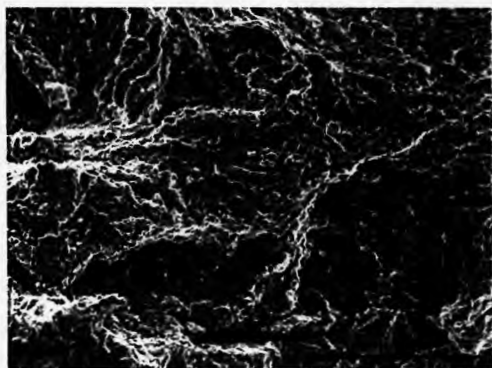
a) dp steel after hydrogen charging with As_2O_3 addition at $15\text{mA}\cdot\text{cm}^{-2}$ for 4 hours

Fig. 4 Fracture surfaces of the dp and trip steels after hydrogen charging with As_2O_3 addition

For higher hydrogen content in the steels, if As_2O_3 was used as hydrogen absorption promoter, very important embrittlement was observed for the both steels. For the DP 750 steel, the fracture was nearly entirely transgranular cleavage (Fig. 4a). For the TRIP steel even irreversible cracking was observed. Fig. 4b shows an example of the fracture surface of the TRIP steel. Large cracks perpendicular to the fracture surface area can be observed there. These cracks were very probably initiated already during hydrogen charging prior to tensile testing on stringers of non-metallic inclusions observed in this steel (Fig.5).

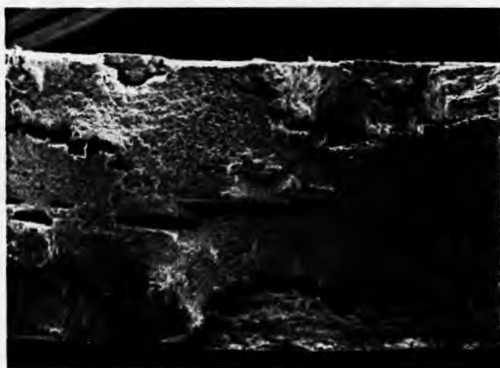
b) TRIP steel after hydrogen charging with As_2O_3 addition at $15\text{mA}\cdot\text{cm}^{-2}$ for 4 hours

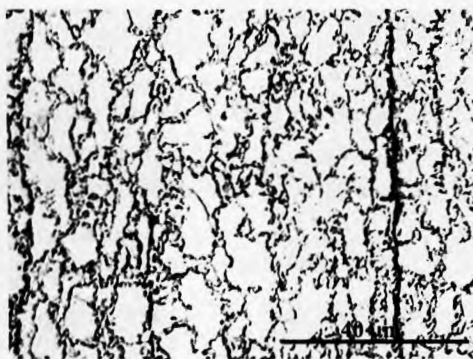
Fig. 5 Stringers of non-metallic inclusions in the TRIP 800 steel

Generally, high resistance to the hydrogen embrittlement is expected in the case of the TRIP steels, mainly thanks to the higher content of residual austenite. It is believed that residual austenite acts as beneficial traps for hydrogen. However, as mentioned above, this beneficial effect depends strongly on the size and shape of residual austenite regions [8]. The presented results show, however, that the resistance of the TRIP steel to the hydrogen embrittlement can be rather poor if all the other requirements are not met. In the presented case, the TRIP steel contained a higher amount of non-metallic inclusions even in the form of stringers, which reduced its resistance to the hydrogen embrittlement.
